KAISER-HILL RESPONSE TO FINAL PUNCH LIST ITEMS FOR SURFACE WATER AND WETLANDS - GAC-108-05

- 1. Pond C-2 engineering as built drawings.
- 2. Pond Operations and Maintenance (O&M) Manual, which is for the A. B and C series ponds, and
- 3. Modified Pond B-5 engineering as built drawings reflecting the work that was completed (other B-5 drawings remain unchanged).

# UNITED STATES DEPARTMENT OF ENERGY ROCKY FLATS ENVIRONMENTAL TECHNOLOGY SITE WATER DIVISION 1, FORMER WATER DISTRICT 2 B-5 DAM OUTLET MODIFICATIONS

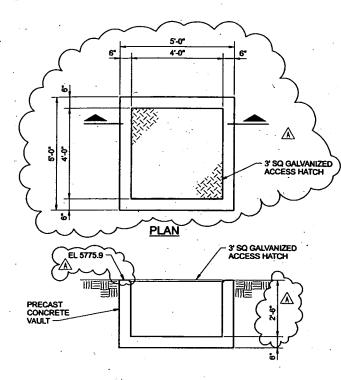
#### **SECTION**

- THE HYDRAULIC PUMP VAULT SHALL BE LOCATED AT THE TOP OF THE DAM EMBANKMENT WITHIN THE ACCESS ROAD AS APPROVED BY THE CONTRACTOR.
- 2. THE HYDRAULIC PUMP AND CONTROLS WITHIN THE VAULT ARE NOT SHOWN. SUBCONTRACTOR SHALL INSTALL THE PUMP AND APPURITENANCES AS RECOMMENDED BY THE MANUFACTURER AND APPROVED BY THE CONTRACTOR.
- 3. THE SUBCONTRACTOR SHALL ORIENT THE PUMP WITHIN THE VAULT AND THE ACCESS HATCH FOR EASE OF OPERATION OF THE MANUAL HYDRAULIC PUMP AND CONTROLS.
- 4. CONTRACTOR SHALL FIELD LOCATE THE WALL PENETRATION OF THE HYDRAULIC LINES CARRIER PIPE THROUGH THE VAULT WALLS. FILL ANNULAR SPACE BETWEEN THE OUTSIDE OF THE PIPE AND THE CONCRETE WALL WITH NON-SHRINK GROUT.
- 5. PROVIDE 2" DIA SCH 80 HDPE PIPE DRAIN PIPE FROM BOTTOM OF WEST INTERIOR WALL OF VAULT TO DRAIN INTO RIPRAP, SLOPE 1 PERCENT. PROVIDE STAINLESS STEEL RODENT SCREEN AT VAULT WALL.

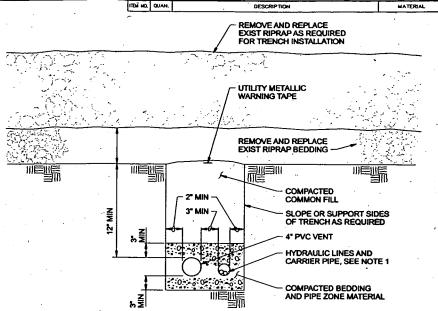
1. TWO HYDRAULIC LINES SHALL BE INSTALLED WITHIN A CARRIER PIPE. THE CARRIER PIPE SHALL BE 2" SCHEDULE 40 STEEL PIPE OR 2 1/2" SCHEDULE 80 PVC.

- 2. THE HYDRAULIC LINES FROM THE SLUICE GATE TO THE PUMP VAULT AT THE TOP OF THE EMBANKMENT SHALL BE INSTALLED WITHIN A CARRIER PIPE IN A COMMON TRENCH WITH THE AIR VENT PIPING. SEE DETAIL 3
- 3. THE ROUTING OF THE CARRIER PIPE FOR THE HYDRAULIC LINES AT THE SLUICE GATE SHALL BE THE FIELD DETERMINED BY THE SUBCONTRACTOR. EXPOSED CARRIER PIPE SHALL BE STEEL PIPE. CARRIER PIPE PENETRATION THROUGH CONCRETE WALL SHALL BE INSTALLED WITH 2" SEEP RING SIMILAR TO

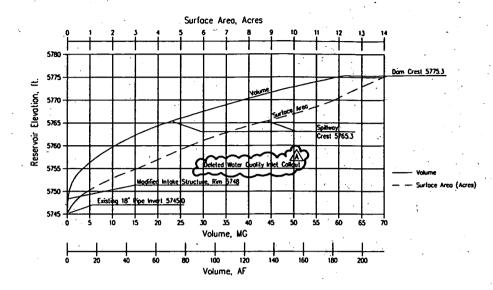
C-2 DAM STAGE, STORAGE AND SURFACE AREA CURVE

Reservoir Elevation (/t.)	Volume (AF)	Volume (MG)	Surface Area (Acres)
5746	0.0	0.0	0.2
5747	0.1	0.0	. 0.2
5748	0.4	0.1	0,4
5749	0.8	0.2	0.6
5750	1.3	0.4	0.9
5751	1.3	0.7	1.3
5752	3.5	1.1	1,7
5753	5.2	1.7	2.1
5754	7.6	2.5	2.6
5755	10.4	3.4	3.1
5756	13.8	4.5	3.7
5757	17.8	5.8	4.2
5758	22.1	7,2	4.5
5759	26.8	8.7	4.9
5760	32.0	10.4	5,4
5761	31.7	12.3	5.0
5762	44.0	14,3	6.5
5763	50.7	16.5	7.0
5764	58.0	18,9	7.6
5765	66.0	21.5	8.5
5765.3	68.5	22.3	8.8
5766	75.1	24.5	9.7
5767	85.1	27.7	10.3
5768	95.6	31.2	10.8
5769	106.8	34.8	11.4
5770	118.4	38.6	11.8
5771	130.4	42.5	12.2
5772	142.8	46.5	12.6
5773	155.7	50.7	13.1
5774	169.0	55.0	13.5
5775	182.8	59.5	14,1
